COLLINGWOOD BEACH PRESERVATION GROUP DUNE VEGETATION MANAGEMENT PLAN OPTION STUDY

COLLINGWOOD BEACH PRESERVATION GROUP

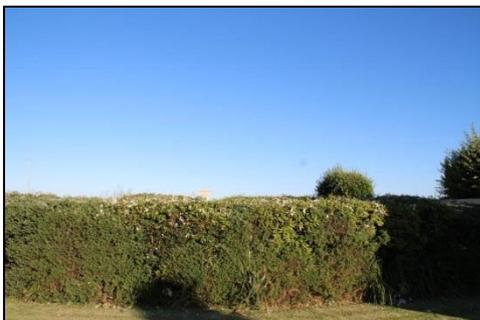
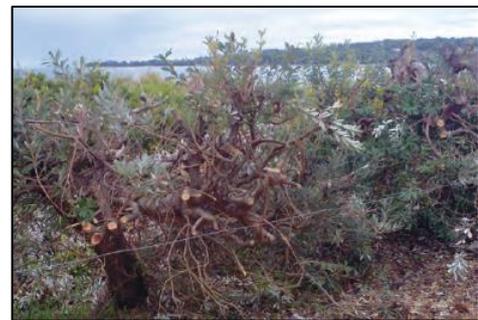
It is clear from the Option 3 poster that SCC and NGH are attempting to discourage people from voting for that Option. Pictures of badly trimmed Banksia hedges have been included in the poster whereas there are many examples of neat hedges along the beach front (see photos below).

Hedge at 2A Albion Street Vincentia

Hedge from Option 3 Poster

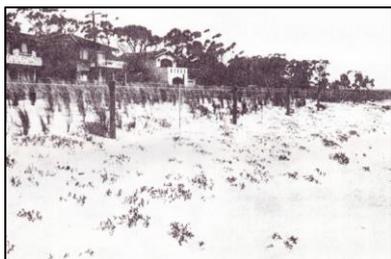
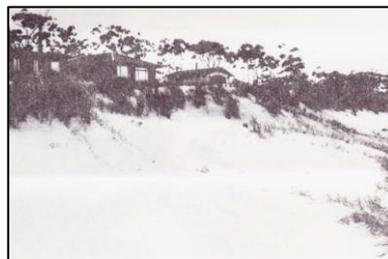
The two photos below have been taken from the article written by P.T. Davies from the Soil Conservation Service of NSW. The article was published in the Journal of the Soil Conservation Service of NSW, 1 January 1982. P.T. Davies was the Nowra District Soil Conservationist at the time the restoration works were undertaken. The photo on the right shows the return of natural dune formation on the northern section of the beach some 14 months after restoration.

Northern Section Collingwood Beach
6 Months After Restoration

Northern Section Collingwood Beach
14 Months After Restoration

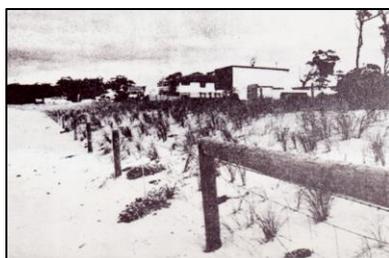
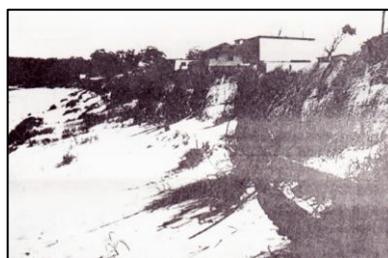
The two photos below have also been taken from the same article. The photo on the right shows considerable sand accretion on the southern section of the beach some 14 months after restoration as evidenced by buried fence posts.

Southern Section Collingwood Beach
6 Months After Restoration

Southern Section Collingwood Beach
14 Months After Restoration

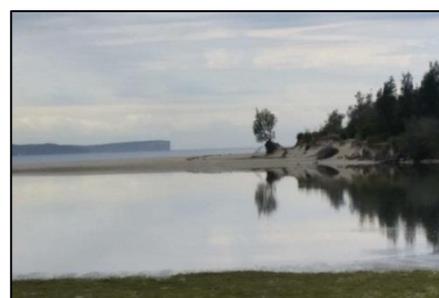
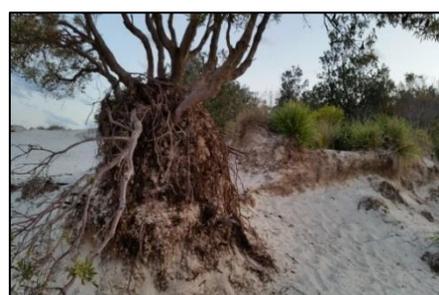
Collingwood Beach
Near Moona Moona Creek

The adjacent photos taken at Collingwood Beach near Moona Moona Creek in November 2015 clearly demonstrate that tree roots do not provide any additional protection to dunes from erosion. It is also relevant to note that the root formation is not extensive.

Item No.	Stated Disadvantages	Fact Check	Reference	Conclusion
1	Higher likelihood of erosion and damage from storm surge in areas with 0% trees.	Trees do not provide additional resistance against erosion. The adjacent photo from Moona Moona Creek Vincentia demonstrates this fact emphatically.	Queensland Environmental Protection Authority and the Beach Protection Authority Coastal Technical Series 2

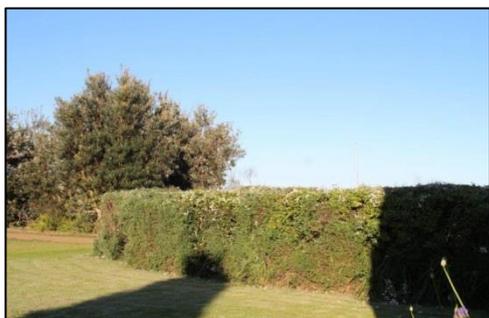
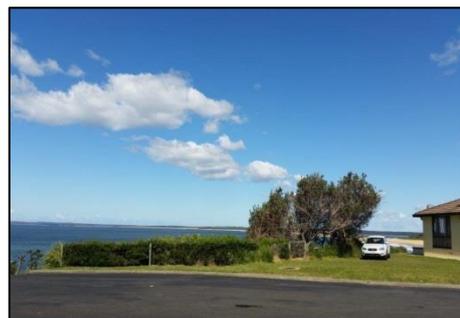
SCC has planted a number of tree varieties in public areas which have been maintained as hedges. The following photos of hedges at Vincentia and Culburra are typical of the hedges that can be found in the Shoalhaven area.

Vincentia

Culburra

The hedge at Vincentia was planted by SCC 14 years ago and has been trimmed annually. There is clear evidence that the trunks of Banksias included in the hedge have continued to thicken and the Banksias grow profusely in the spring and summer months. There is also anecdotal evidence that the roots have continued to grow even though the Banksias have been continually trimmed.

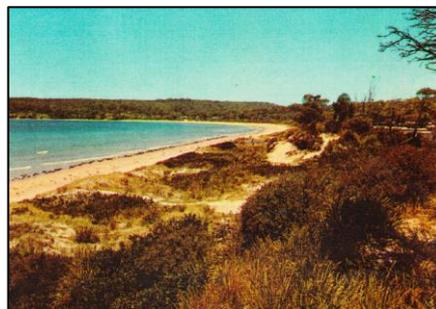
Banksias are a native vegetation. There is no evidence that Banksias were common at Collingwood Beach when subdivision for waterfront properties occurred in the early 1950s (see photo). It appears that Banksias were initially extensively planted in conjunction with the 1978 beach restoration. As such there has been no 'clearing' (as defined under the Act) of Banksias from the dunes.

Collingwood Beach circa 1950

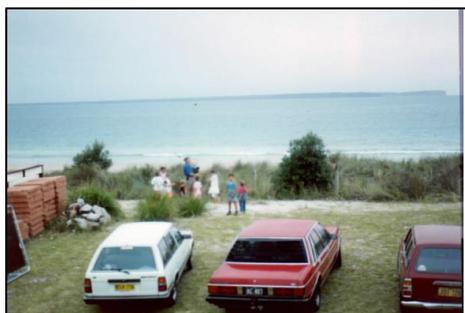
The photos below show the vista enjoyed by residents and tourists prior to the planting of Banksias. Although it is a moot point it is relevant to note that the photos were taken after 1 January 1990 confirming that Banksias were planted after the cut-off date in the Act.

68 Elizabeth Drive
Vincentia 1992

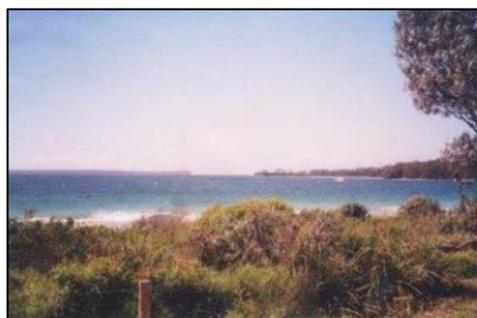
1A Susan Street
Vincentia 2001

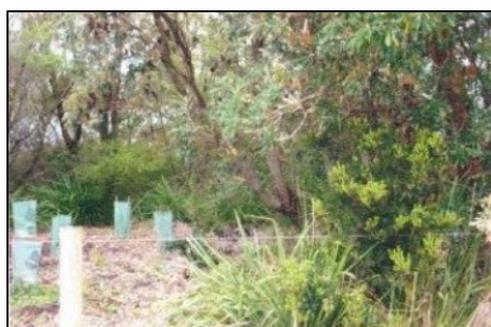
1A Susan Street
Vincentia April 2015

The adjacent photo from outside 1A Susan Street Vincentia taken in April 2015 provides a clear demonstration as to how Banksias grow into thickets that block views.
